Land Subsidence Rate in the Elfrida Area, Cochise County  
Based on Radarsat-2 Satellite Interferometric Synthetic Aperture Radar (InSAR) Data  
Time Period of Analysis: 1.0 Years 03/26/2013 To 03/21/2014

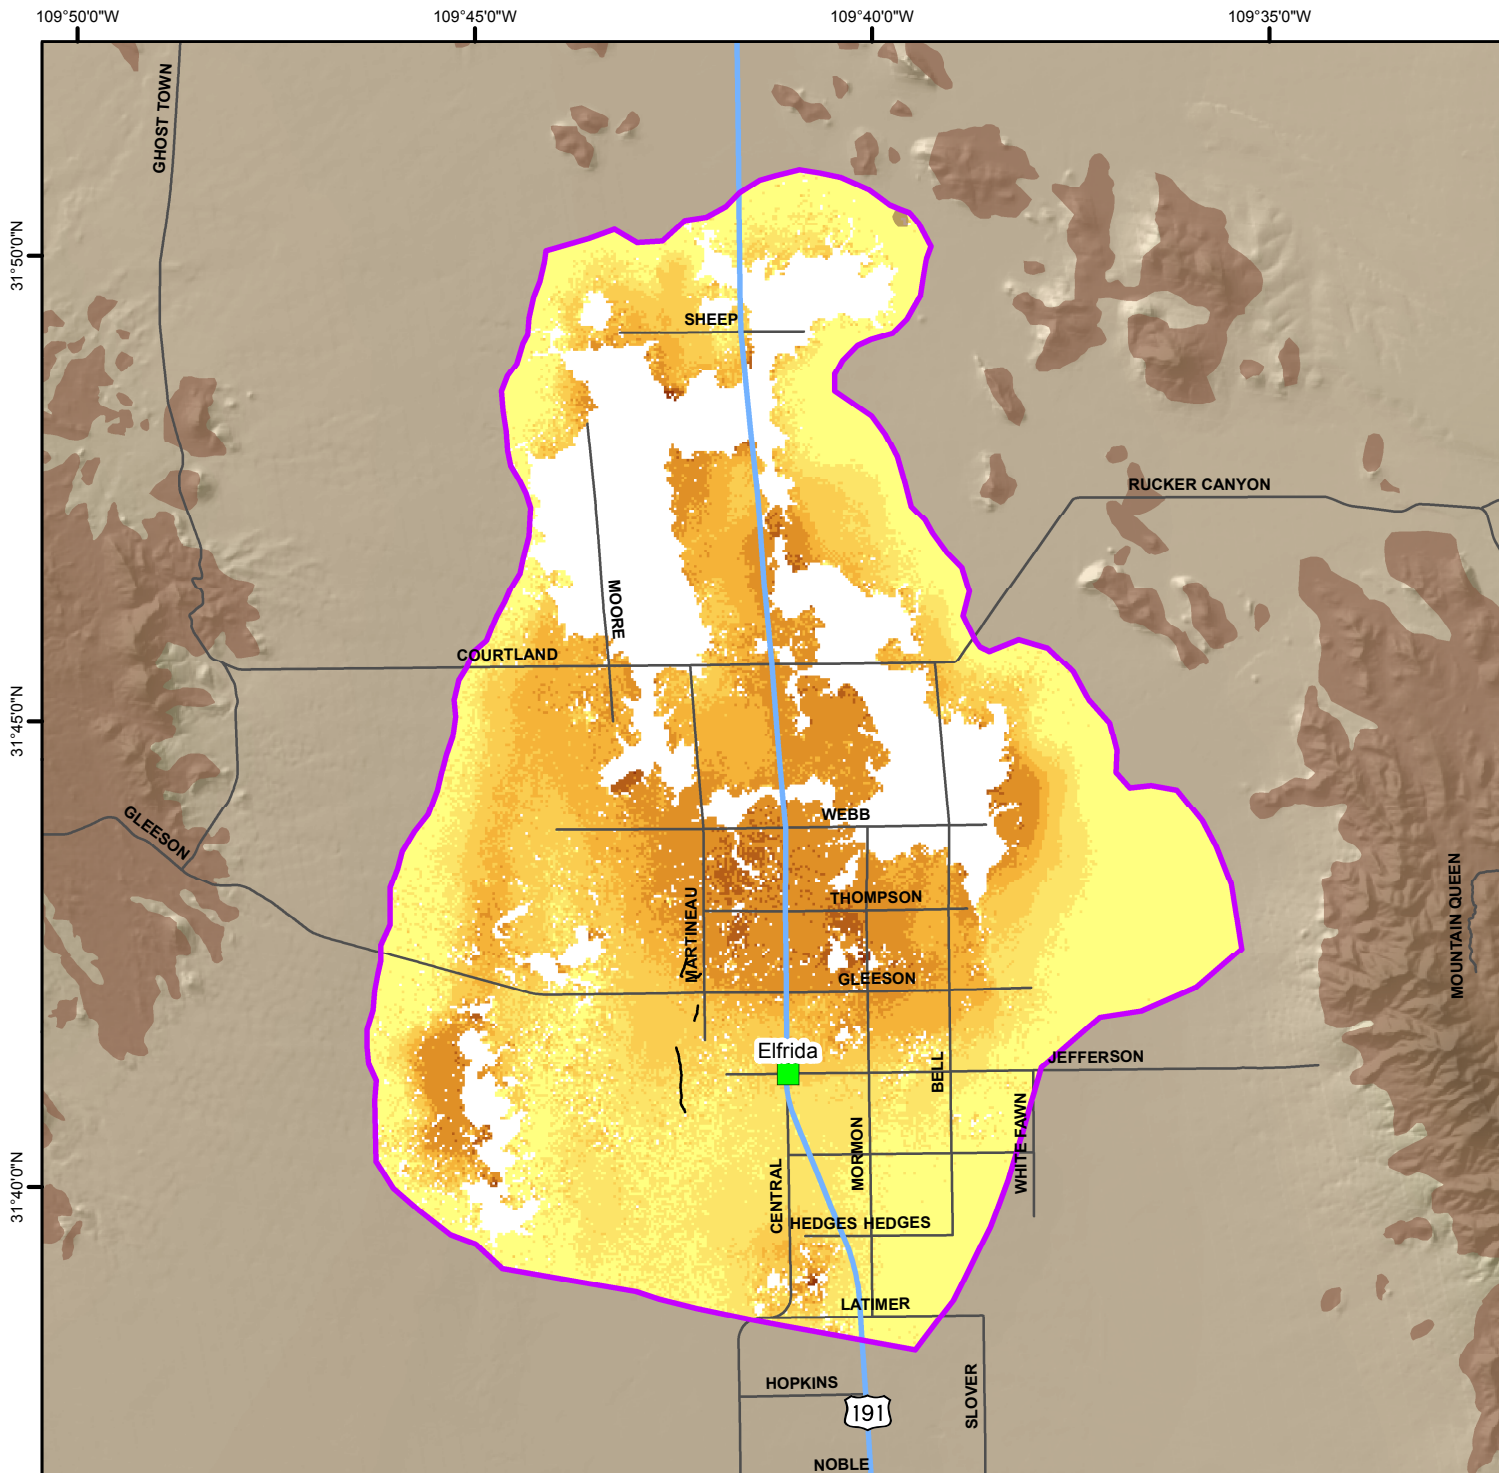
Decorrelation (white areas) are areas where the phase of the received satellite signal changed between satellite passes, causing the data to be unusable. This occurs in areas where the land surface has been disturbed (i.e. bodies of water, snow, agriculture areas, areas of development, etc).

Earth fissures were mapped by the Arizona Geological Survey. For information on earth fissures visit: [www.azgs.az.gov/EFC](http://www.azgs.az.gov/EFC)
